# UNDERWATER BRIDGE INSPECTION REPORT

STRUCTURE NO. 30501

CSAH NO. 7

RUM RIVER

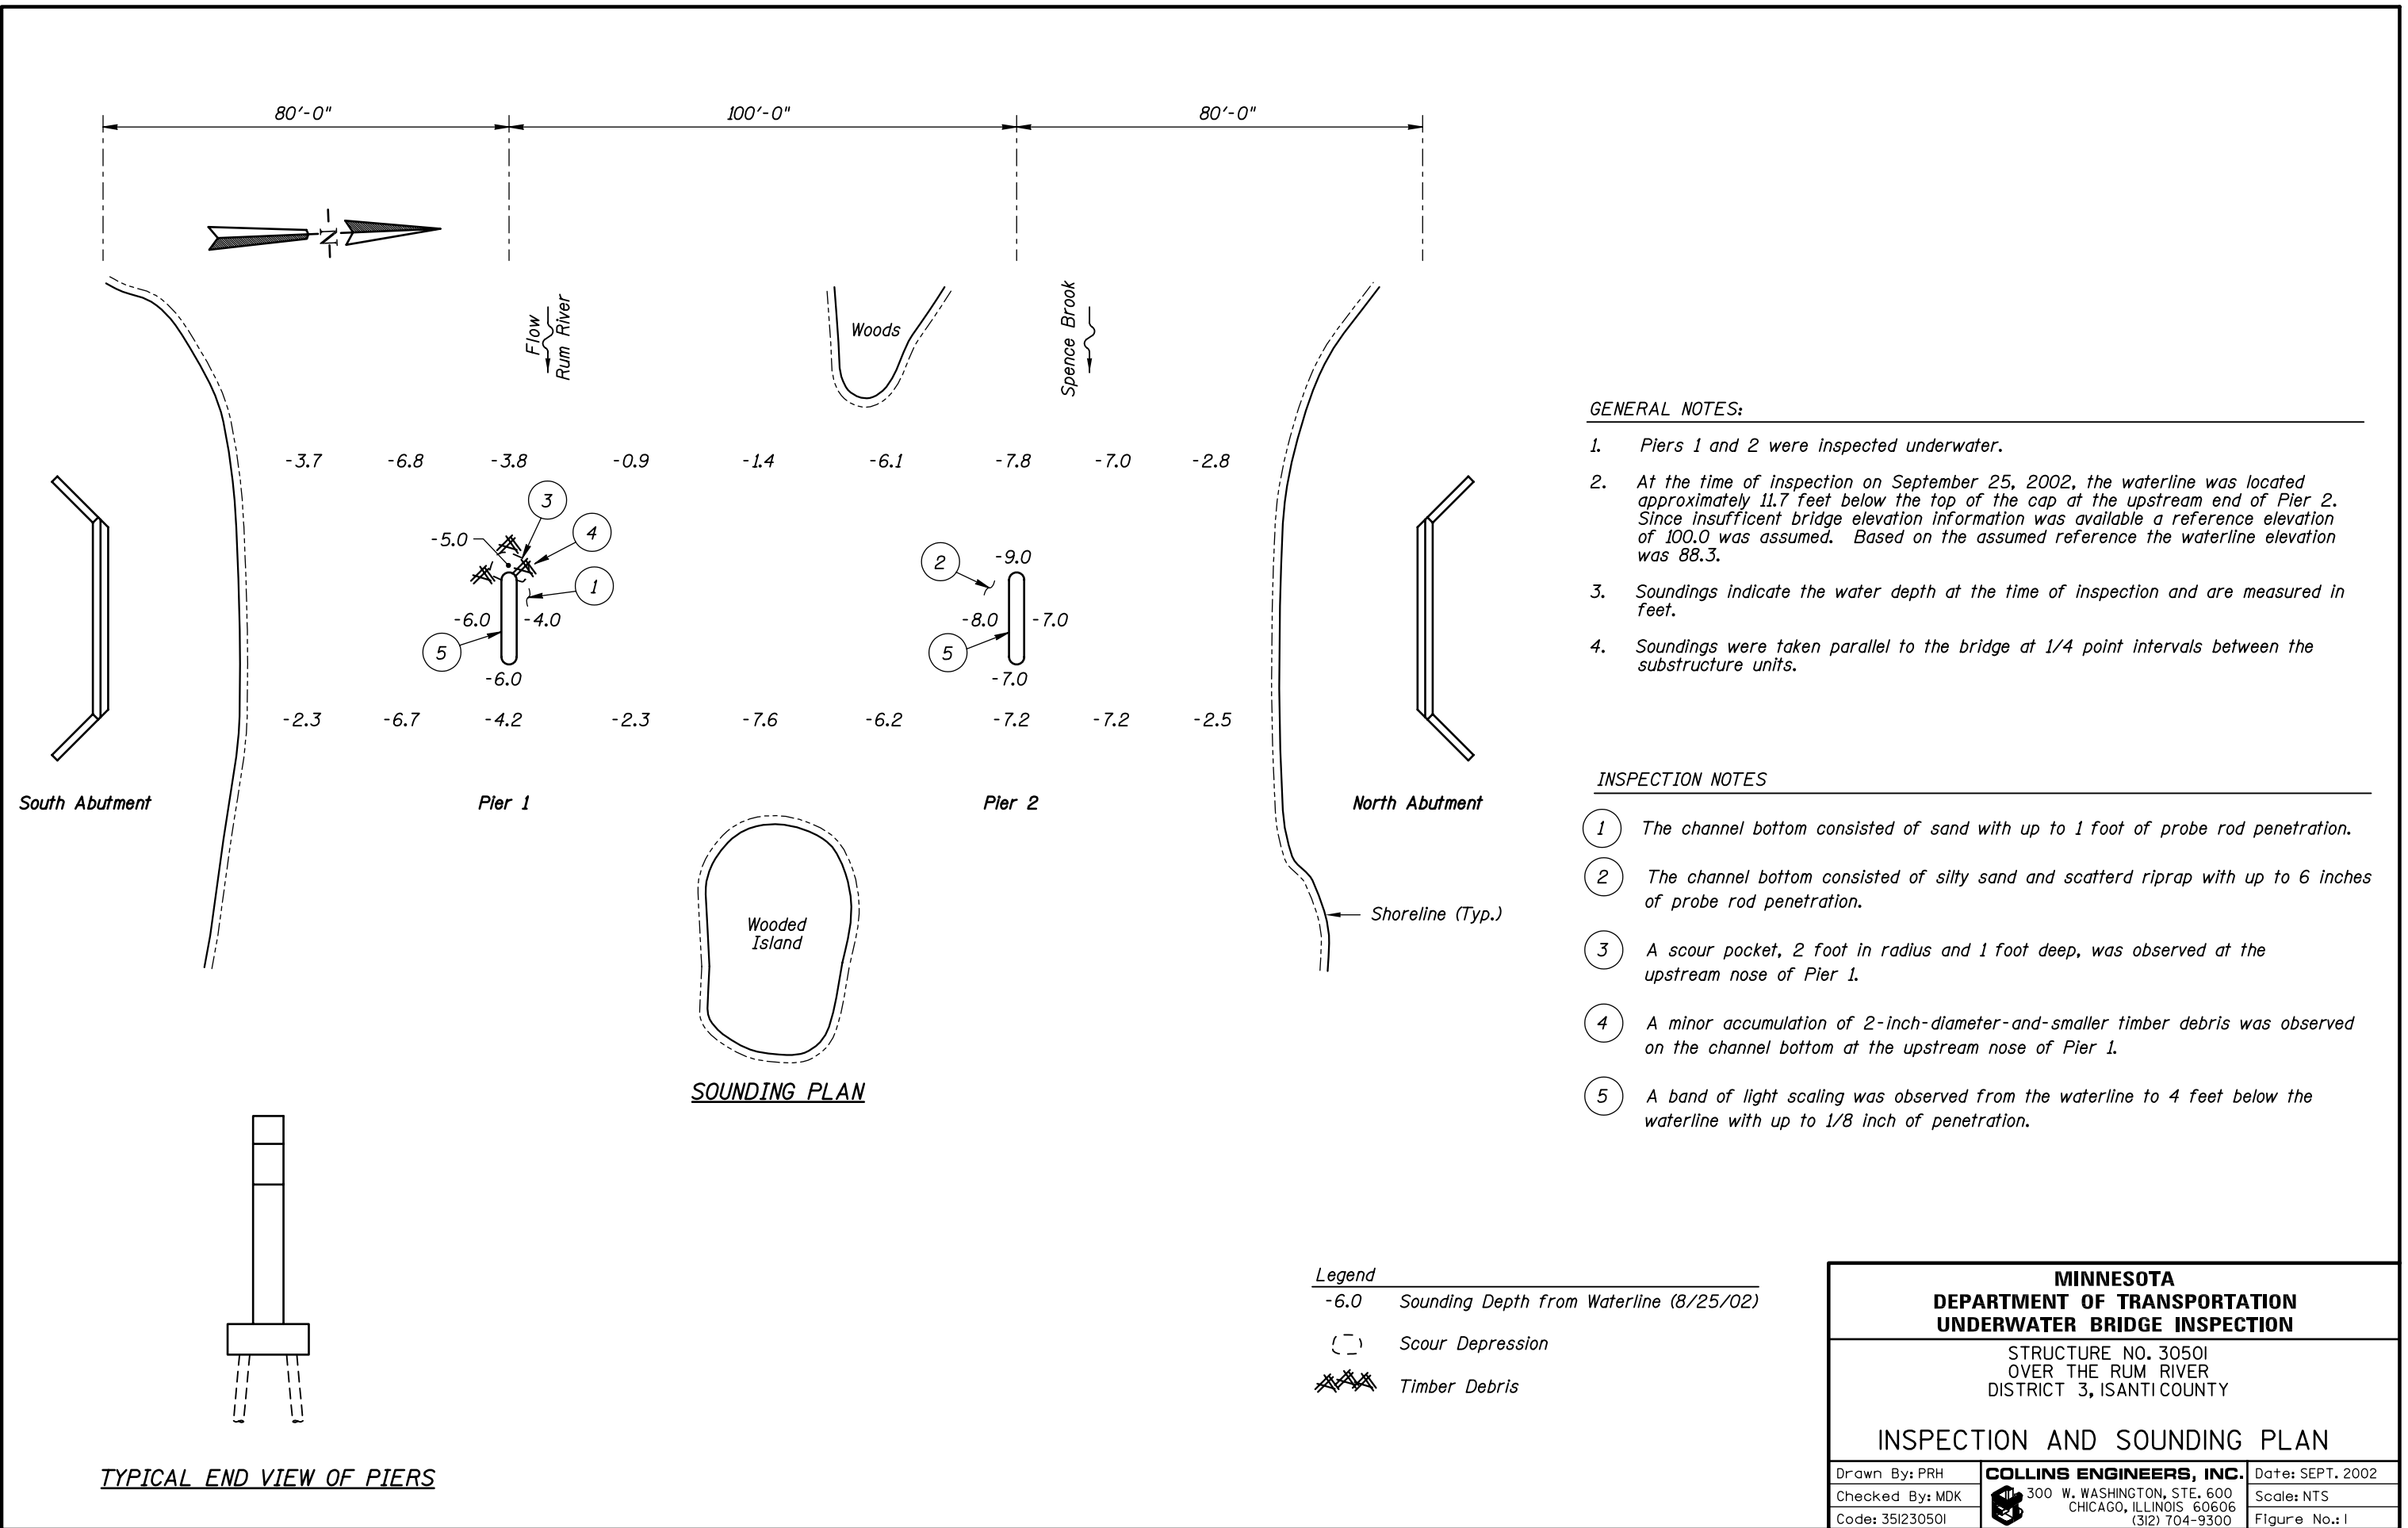
UPSTREAM FASCIA PROFILE

REMARKS: Overall, the concrete of the piers was in good condition. A band of light scaling, extending from the waterline to 4 feet below the waterline, with up to 1/8 inch of penetration was observed at both piers. A minor scour depression, 2 foot in radius and 1 foot deep, was observed on the upstream nose of Pier 1 with a minor accumulation of timber debris in the base of the scour.

Reinspect the submerged substructure units at the normal maximum recommended (NBIS) interval of five (5) years.
